# SERVICE BULLETIN

AMERICAN HONDA MOTOR CO., INC. MOTORCYCLE SERVICE DEPARTMENT

## GL1500 CB RADIO SUB-HARNESS

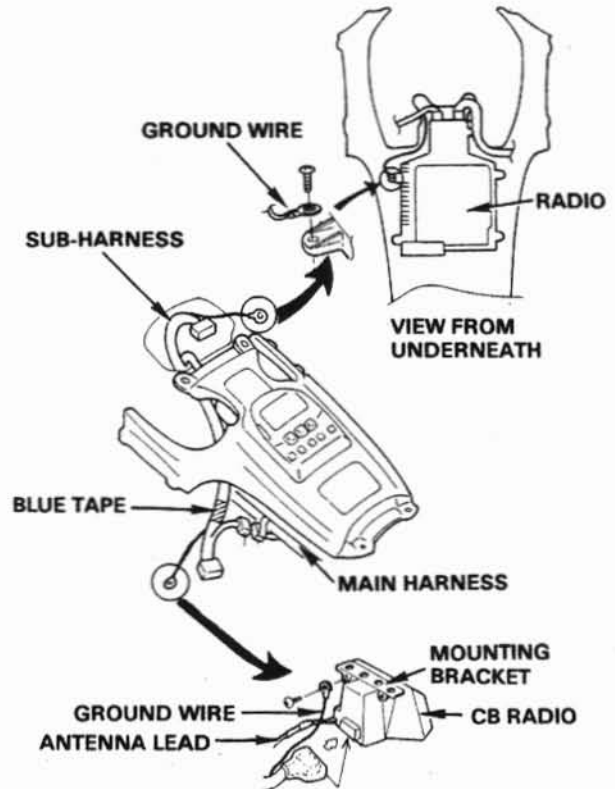
For future identification, remove the left fairing side pocket. A ground wire attached to the CB mounting bracket indicates the new sub-harness (or a CB with serial number 6656 or above) has already been installed. The sub-harness for this repair is also wrapped with blue tape in the area shown above.

Installation instructions are included with the sub-harness kit. Follow the instructions carefully for proper sub-harness installation.
