Service Bulletin

SAFETY RECALL

2001-2002 GL1800/A Frame Weld Inspection

(This supersedes GL1800/A #17, dated February 2005)

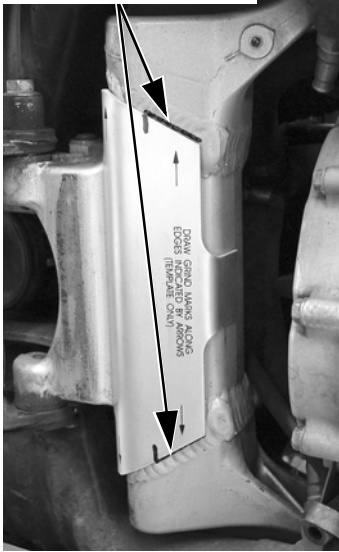
Draw 30 mm lines here.

Lines DO NOT extend around corners.

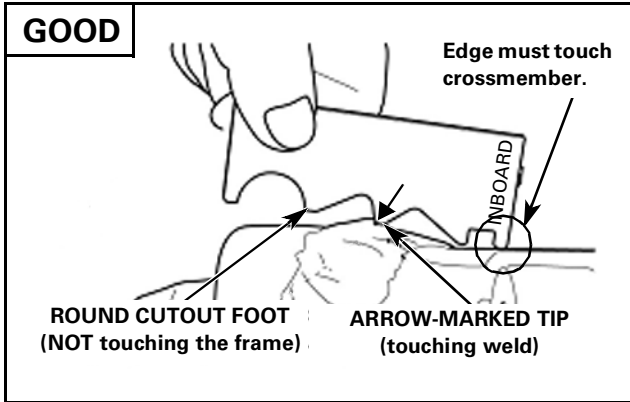
If the arrow-marked tip touches the weld bead "peaks" (top of each weld bead) along the entire length of the marker lines, the welds are GOOD (see illustration on the next page). Raise the motorcycle and reinstall all parts in the reverse order of removal. Proceed to the IDENTIFICATION section of this Service Bulletin.

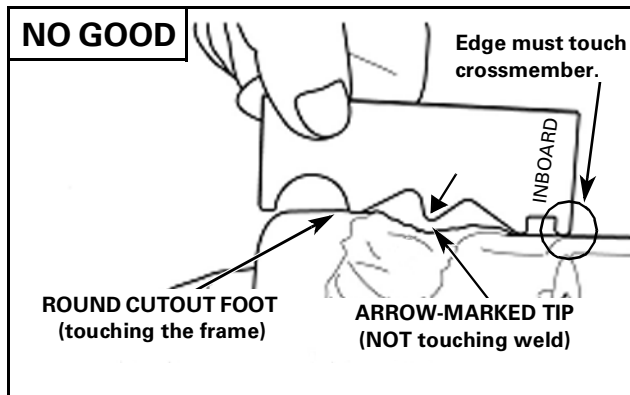
If the arrow-marked tip **DOES NOT** touch the weld bead peaks along the entire length of the marker line, the welds are NO GOOD (see the NO GOOD illustration).

If your inspection indicates a NO GOOD weld **on either side**, you must weld **both** sides. Proceed to the REPAIR PROCEDURE section.
