Service Bulletin

GL1500 # 9
APRIL, 2000

EMISSIONS RECALL

Defective 3-Way "T" Fitting To The Air Injection Control Valve (AICV)

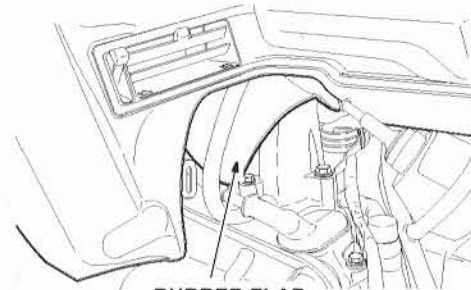
RUBBER FLAP

1. Remove the left engine cover for access to the 3-way "T" fitting. Locate the rubber flap covering the intake manifold as shown; fold it out of the way.

Fold flap up and out of the way.

Look up between intake manifold for "T" fitting location.

The "T" fitting is located behind the rubber flap. Look up between the intake manifold.

Replacement of the 3-way "T" fitting as described in this bulletin will ensure that the emission control systems continue to perform as designed.
