Service Bulletin

SAFETY RECALL

2001-2002 GL1800/A Frame Weld Inspection

(This supersedes GL1800/A #17, dated February 2005)

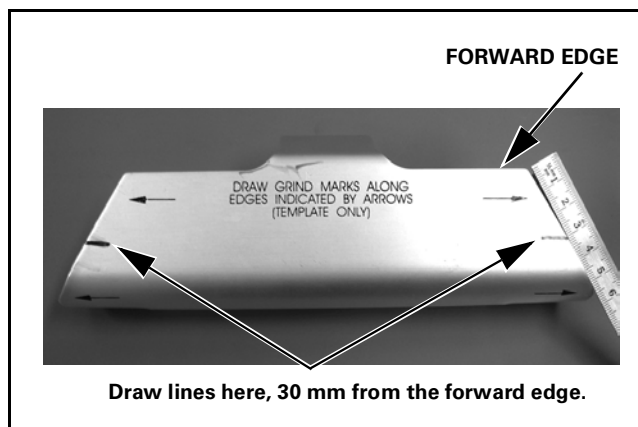
9. Clean the frame crossmember with acetone.
10. Draw a line on each side of the **grinding template** (S0512) 30 mm from the forward edge, stopping between the two arrows, as illustrated below.

11. Put this template on the frame and, using a fine-tipped felt marker (such as a Sharpie), draw a **30 mm line** on both crossmember welds. Start this line at the **forward edge** of the grinding template and stop between the two arrows as shown in the illustration on the next page. Now remove the grinding template.

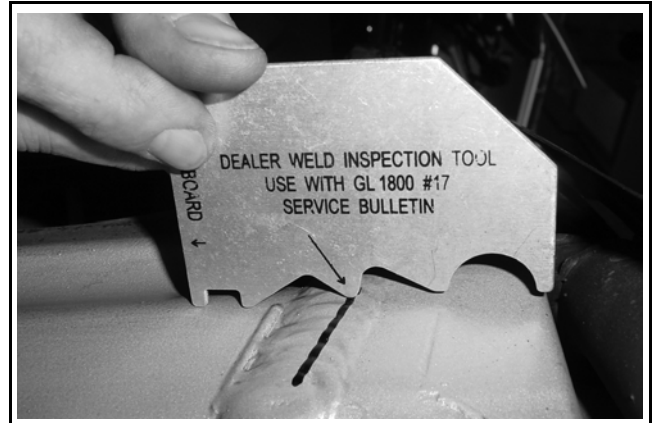
- Place the Weld Inspection Tool on the crossmember with the INBOARD side facing the center of the crossmember. The inboard edge of the tool should contact the crossmember at all times, with the arrow-marked tip touching the marker line.

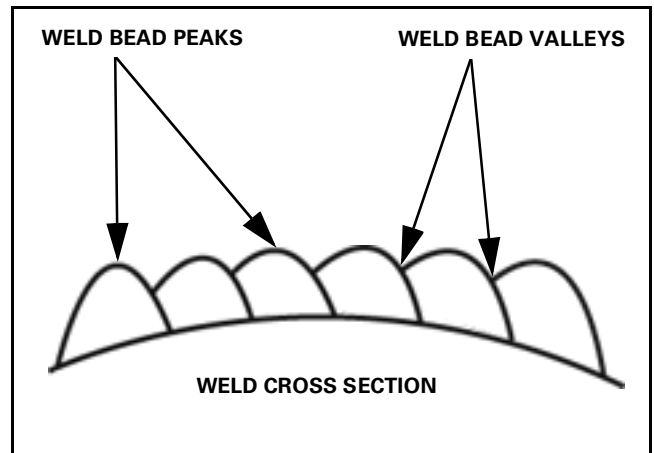
- Move the tool along the full length of the marker line, at a right angle to the line. As you move the tool along the 30 mm line, the arrow-marked tip should contact the "peaks" of the weld. The tip does not need to make contact with the "valleys" of the weld beads.

If the arrow-marked tip touches the weld bead "peaks" (top of each weld bead) along the entire length of the marker lines, the welds are GOOD (see illustration on the next page). Raise the motorcycle and reinstall all parts in the reverse order of removal. Proceed to the IDENTIFICATION section of this Service Bulletin.

If your inspection indicates a NO GOOD weld **on either side**, you must weld **both** sides. Proceed to the REPAIR PROCEDURE section.

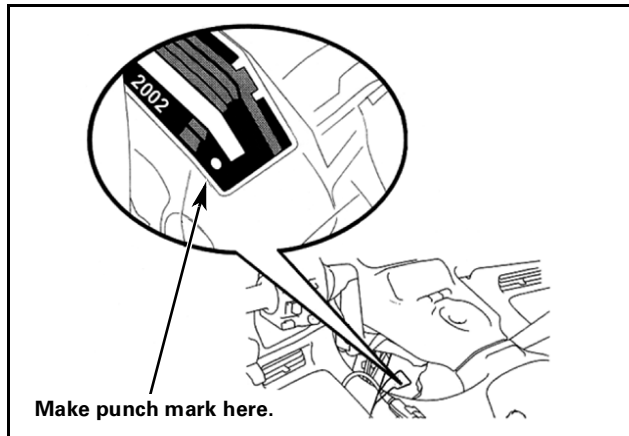
If your inspection has determined both crossmember welds to be good, make a punch mark on the lower right hand corner of the VIN plate, as shown below.

If you needed to repair the crossmember welds, after you have completed the disassembly, welding, painting, and re-assembly procedures, make a punch mark on the lower right hand corner of the VIN plate, as shown below.
